KILARC-COW Creek PROJECT
FERC NO. 606

**HABITAT ASSESSMENT FOR THE
CALIFORNIA RED-LEGGED FROG
(RANA AURORA DRAYTONII) IN THE
KILARC-COW PROJECT AREA**

April 20, 2004

**SITE ASSESSMENT FOR CALIFORNIA RED-LEGGED FROG
(*RANA AURORA DRAYTONII*) HABITAT
IN THE KILARC-COW PROJECT AREA**

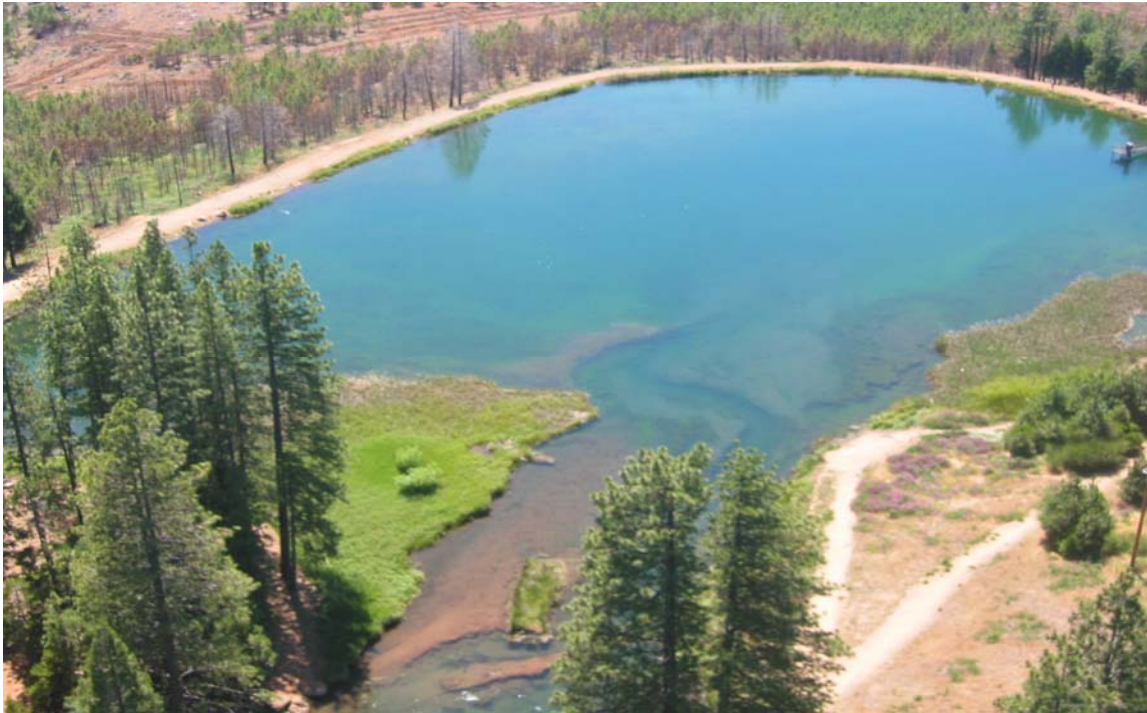
Site 12B. Aerial photograph
July 8, 2003

Site 12B. Kilarc Forebay

Emergent and submersed vegetation characteristic of CRLF spawning habitat is absent from the diversions at the upper ends of Old Cow and South Cow bypass reaches. Emergent vegetation exists along the southeastern part of Kilarc Forebay (Old Cow Creek basin) and along part of Cow Creek forebay (South Cow Creek basin) but the water depth drops off rapidly around the banks of both reservoirs. The presence of large trout in Kilarc Forebay indicates also that the water is too cold for CRLF spawning habitat. Additionally, bullfrogs and green sunfish (potential predators of CRLF) are present in the Cow Creek Forebay. The diversions and forebays collectively offer no CRLF spawning habitat.

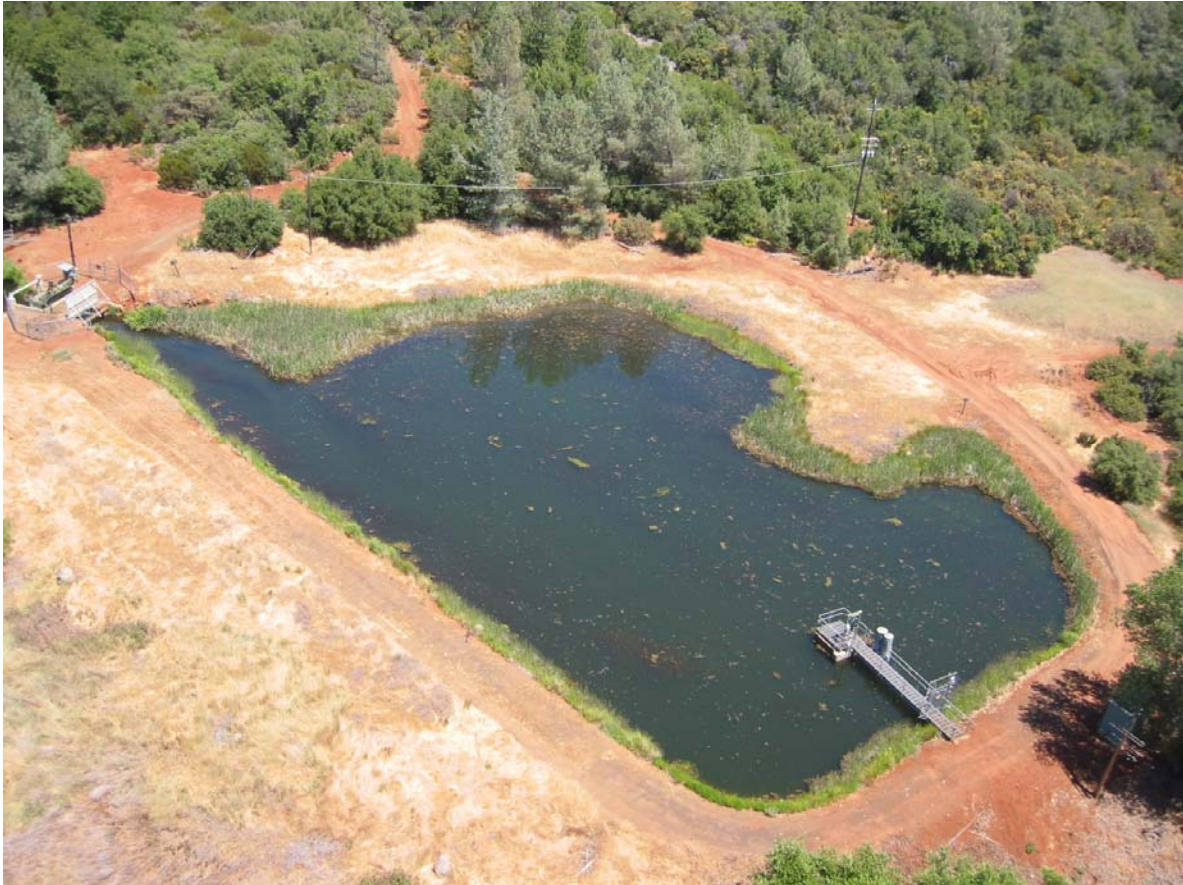
Site 61a. Aerial photograph
July 8, 2003

Site 61a. Cow Creek Forebay

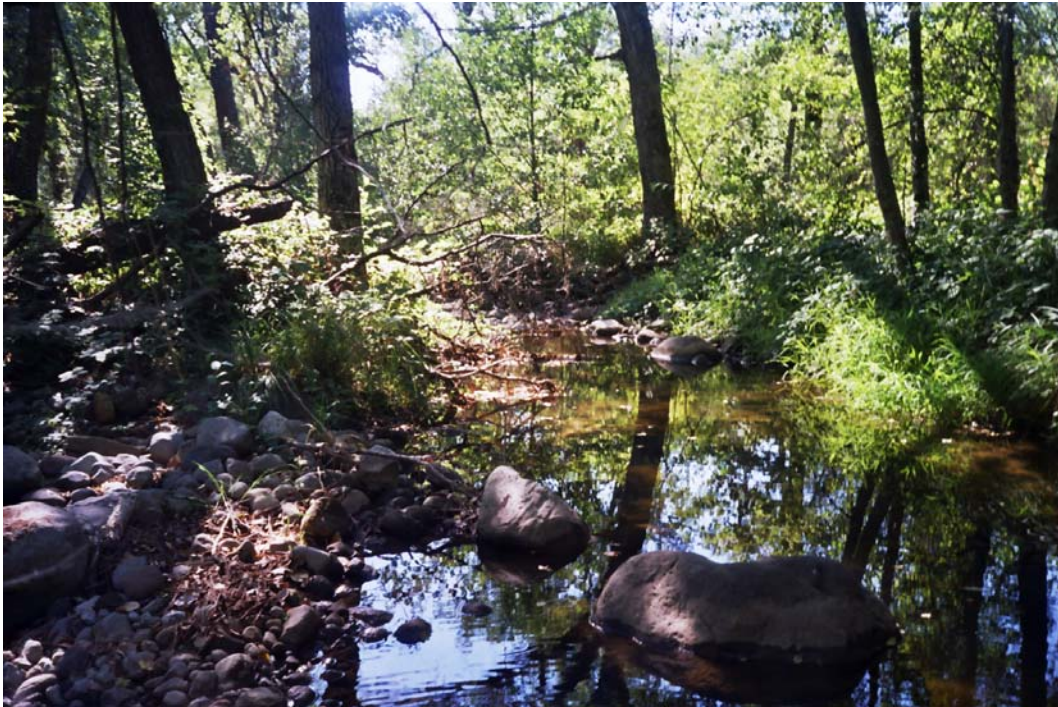
Site 64. Ground photograph 1
September 5, 2003

Site 64. Hooten Gulch, downstream 1/3 above South Cow Creek confluence

Hooten Gulch within 100 meters of its junction with South Cow Creek offers potential summer habitat for adult CRLFs. Though Hooten Gulch within this bracket has an aggregate substratum there are also muddy substrata, very slow warm water, and moderately undercut banks. The forest canopy was estimated to be about 70-75%. The site assessment crew observed a large western pond turtle (*Clemmys marmorata*) at Hooten Gulch on September 5, 2003. These turtles frequently occur in CRLF habitat, though their presence does not necessarily indicate the presence of CRLFs. Several foothill yellow-legged frogs were observed within 100 meters of the confluence with South Cow Creek, and the stream channel was the only site found within the Site Assessment Area that CRLFs might use as summer habitat. However, as stated previously, “potential summer habitat” may become “actual summer habitat” only if occupied spawning habitat exists within one mile.
