Exhibit E: Environmental Report

EXHIBIT E: ENVIRONMENTAL REPORT

Exhibit E presents the Environmental Report for the Kilarc-Cow Creek Hydroelectric Project (Project) License Surrender Application (LSA). The Environmental Report is divided into three major sections: Affected Environment (Section E.2), Project Impacts (Section E.3), and Protection, Mitigation, and Enhancement (PM&E) Measures (Section E.4). Within each section, the environmental and cultural resources of the Project Area are addressed in the following order: geology and soils, hydrology and water resources, geomorphology, water quality, aquatic resources, wildlife resources, botanical resources, historical resources, archeological resources, recreation, aesthetics, and land use.

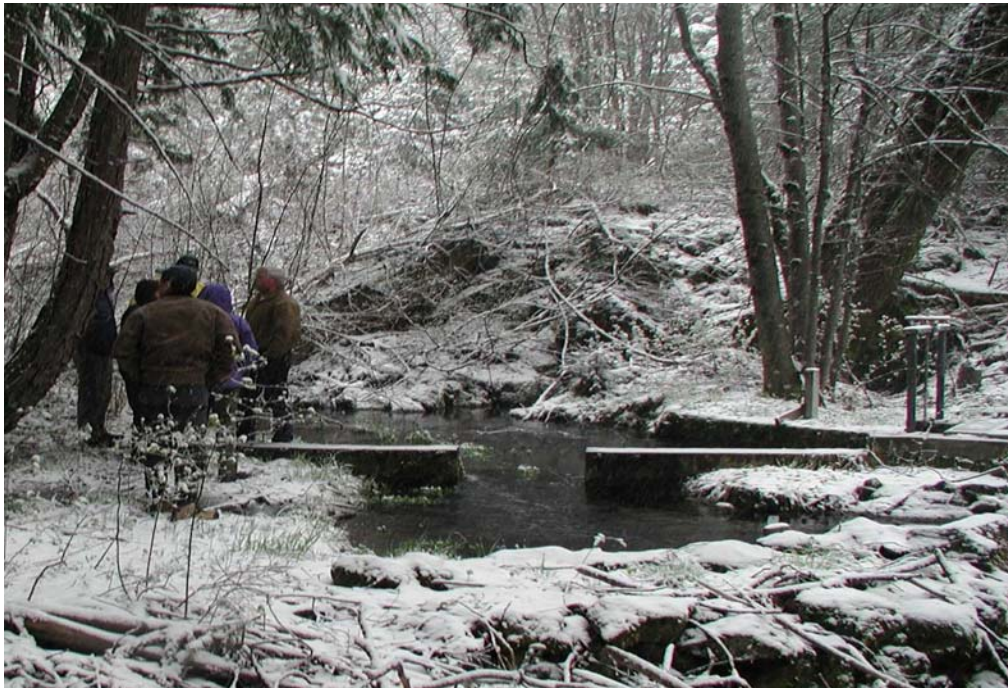
Photograph E.2.3-1. South Canyon Creek Dam and Diversion

There are three other diversion dams located within the Project Area, North Canyon Creek and South Canyon Creek diversion dams (Photograph E.2.3-1) in the Kilarc Development, and Mill Creek Diversion Dam located on Mill Creek (Photograph E.2.3-2) within the Cow Creek Development.

All of these impoundments are small in size, resulting in a very small volume of potentially stored sediment, if at all. Sediments most likely have been passing over these small diversions into the downstream reaches throughout the period of past Project operations. The removal of the Mill Creek, North Canyon Creek, and South Canyon Creek diversion dams under the decommissioning of Project facilities would restore the annual peak runoff magnitude, and the associated sediment transport capacity of these channels.

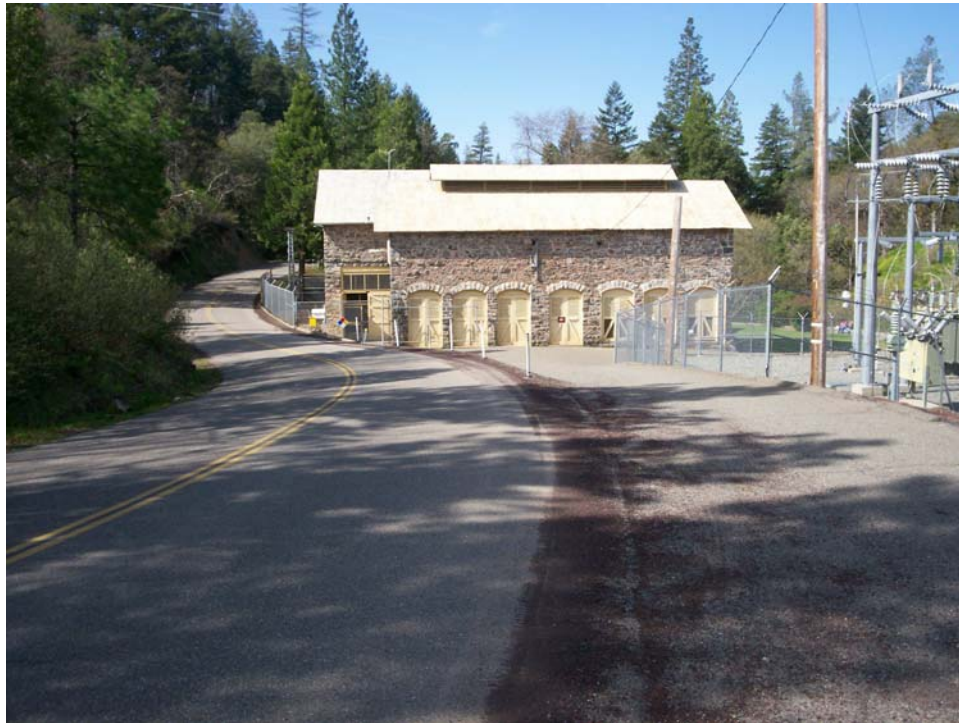
Photograph E.2.11-1. KOP 1

- KOP 1 (Photograph E.2.11-1) is a point directly north of Kilarc Powerhouse on East Fern Road, a travel corridor to the Project Area. The powerhouse and switchyard is clearly visible from this KOP.
- KOP 2 (Photograph E.2.11-2) overlooks Kilarc Forebay to the northwest from Kilarc Forebay Day Use Area. The Kilarc Forebay Dam is visible from this KOP.
