EXHIBIT E: ENVIRONMENTAL REPORT

Exhibit E presents the Environmental Report for the Kilarc-Cow Creek Hydroelectric Project (Project) License Surrender Application (LSA). The Environmental Report is divided into three major sections: Affected Environment (Section E.2), Project Impacts (Section E.3), and Protection, Mitigation, and Enhancement (PM&E) Measures (Section E.4). Within each section, the environmental and cultural resources of the Project Area¹ are addressed in the following order: geology and soils, hydrology and water resources, geomorphology, water quality, aquatic resources, wildlife resources, botanical resources, historical resources, archeological resources, recreation, aesthetics, and land use.

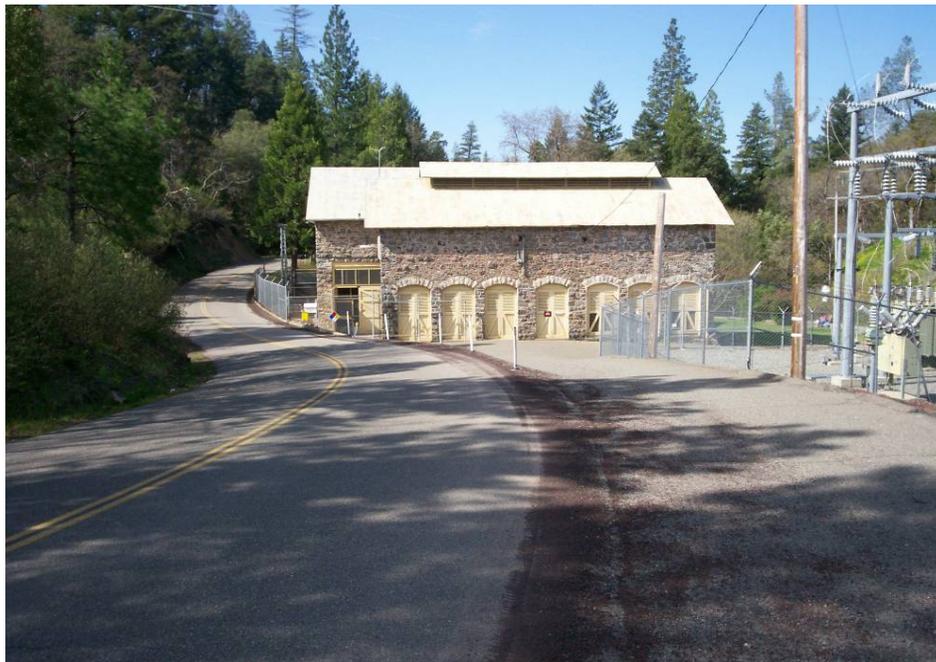
Photograph E.2.11-1. KOP 1

- KOP 1 (Photograph E.2.11-1) is a point directly north of Kilarc Powerhouse on Fern Road East, a travel corridor to the Project Area. The powerhouse and switchyard is clearly visible from this KOP.
- KOP 2 (Photograph E.2.11-2) overlooks Kilarc Forebay to the northwest from Kilarc Forebay Day Use Area. The Kilarc Forebay Dam is visible from this KOP.

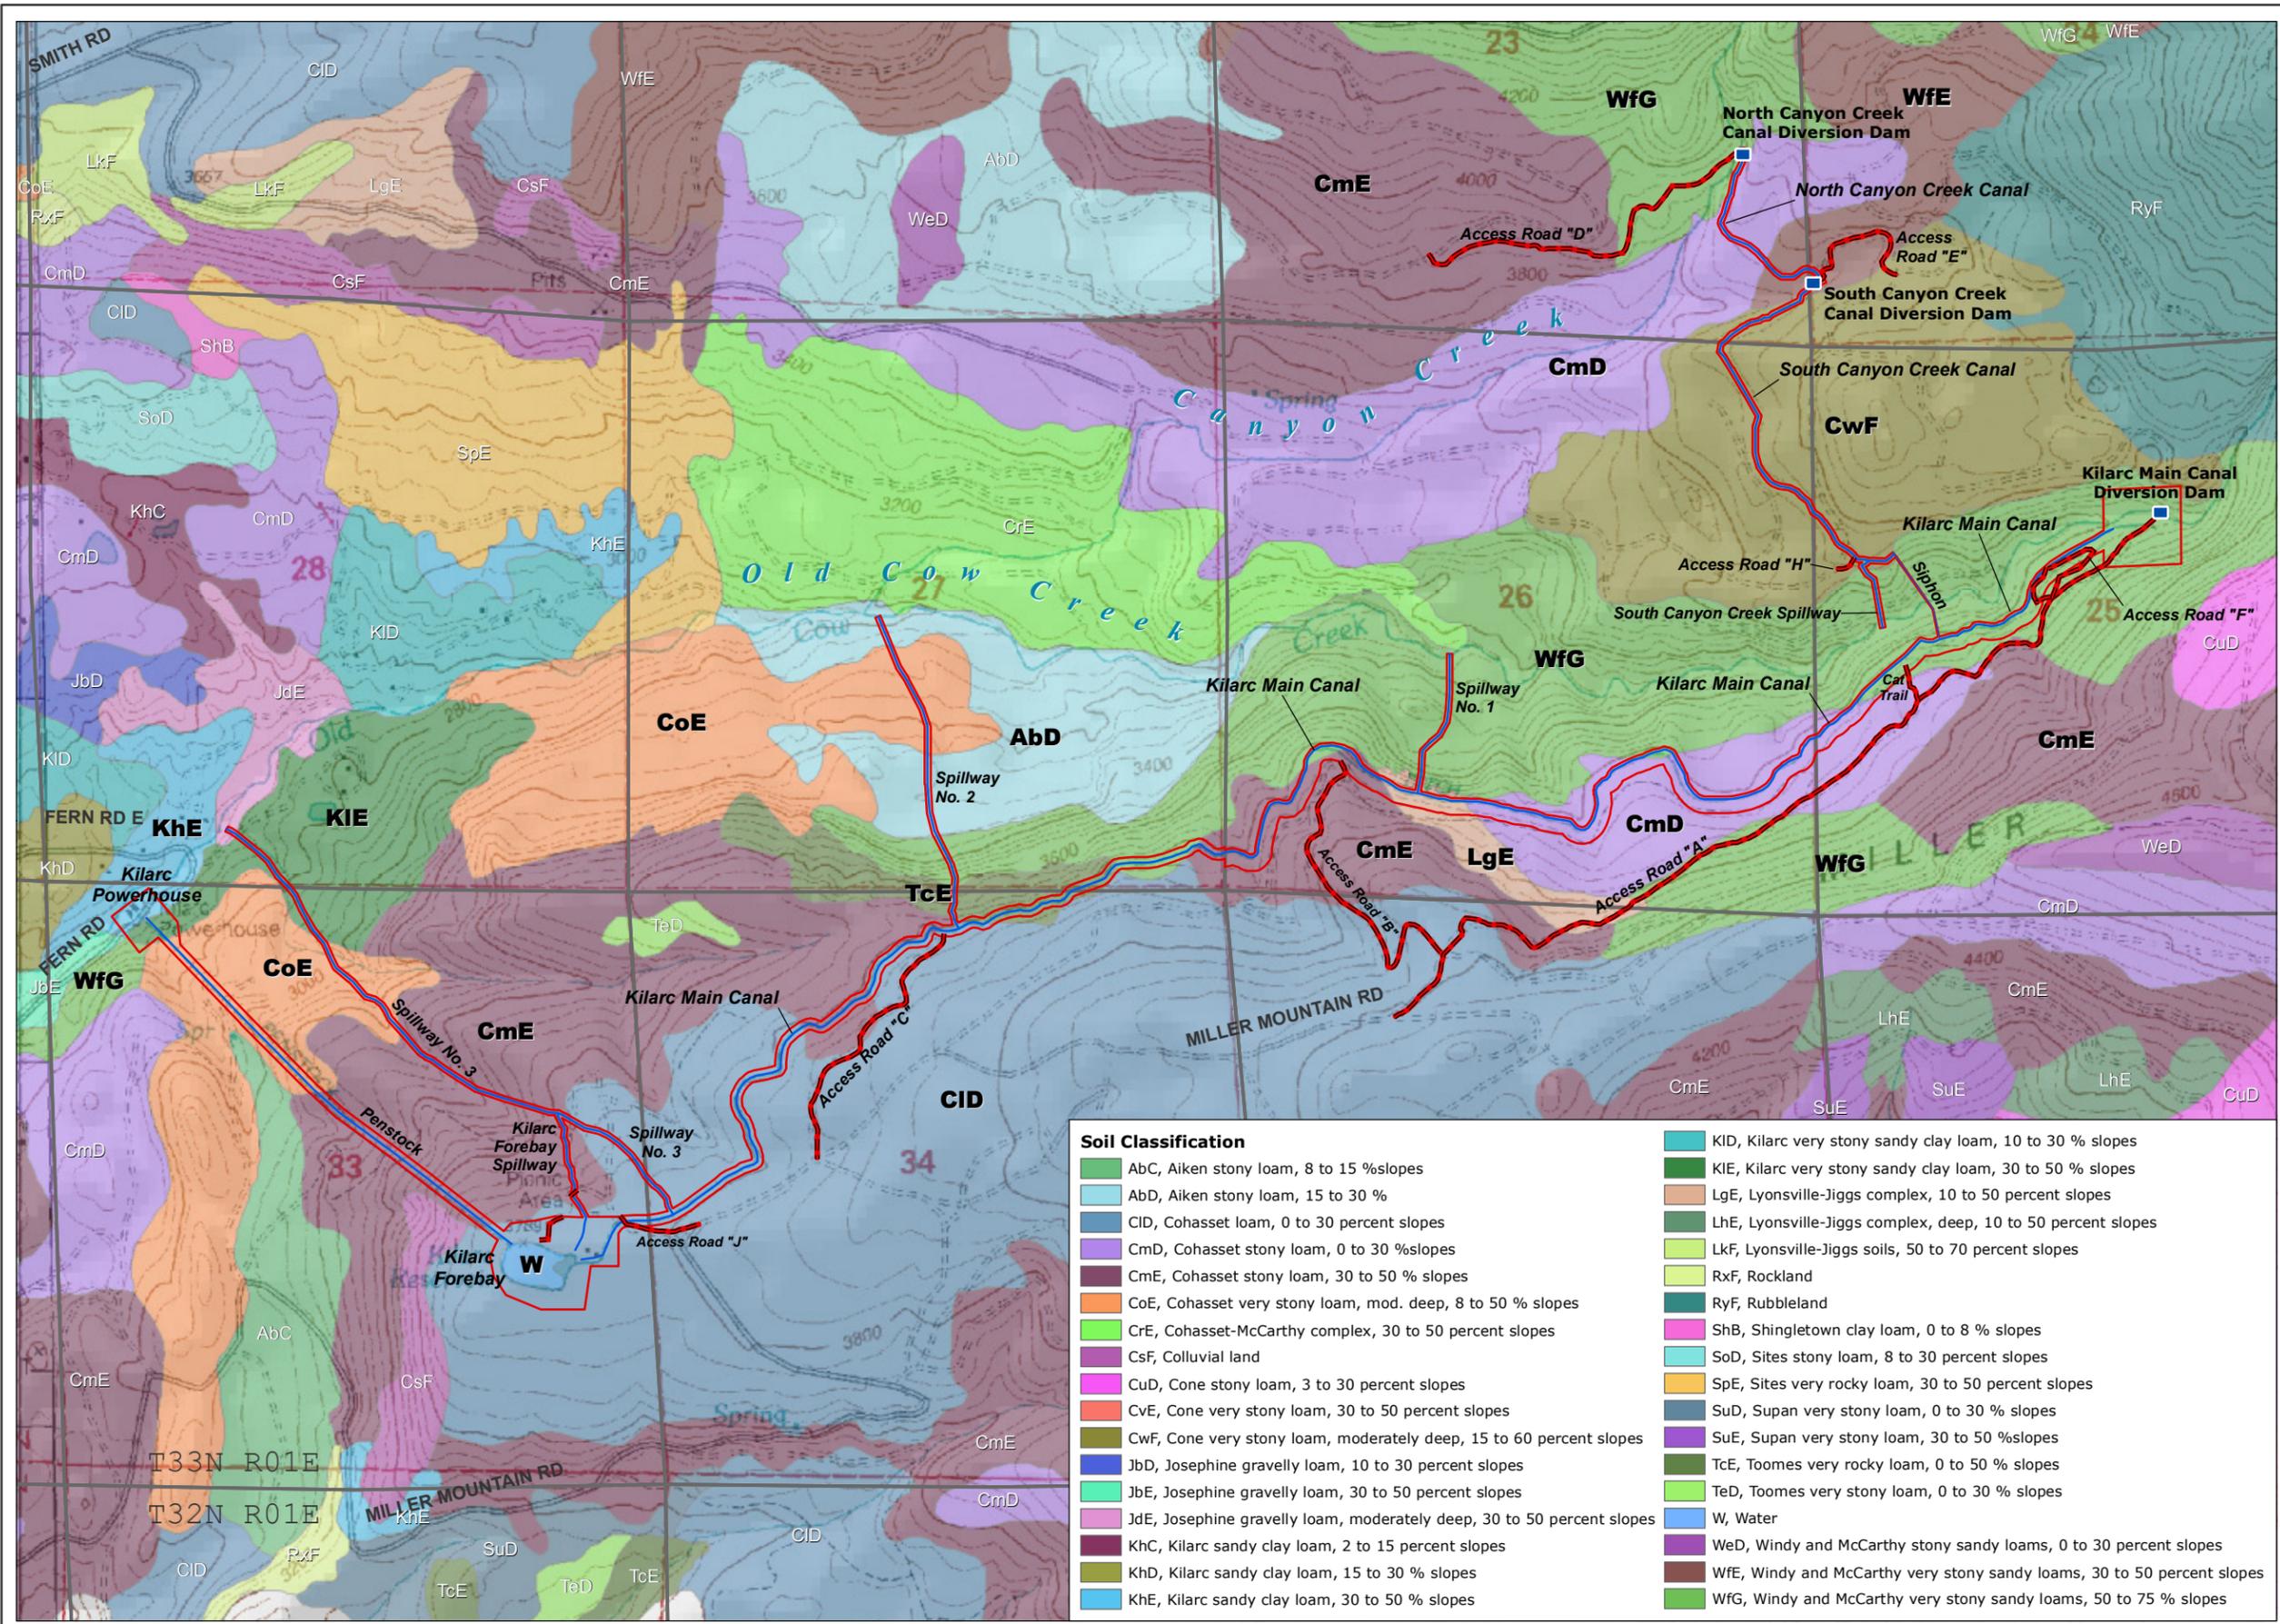
Soil Classification

AbC, Aiken stony loam, 8 to 15 %slopes	KID, Kilarc very stony sandy clay loam, 10 to 30 % slopes
AbD, Aiken stony loam, 15 to 30 %	KIE, Kilarc very stony sandy clay loam, 30 to 50 % slopes
CID, Cohasset loam, 0 to 30 percent slopes	LgE, Lyonsville-Jiggs complex, 10 to 50 percent slopes
CmD, Cohasset stony loam, 0 to 30 %slopes	LhE, Lyonsville-Jiggs complex, deep, 10 to 50 percent slopes
CmE, Cohasset stony loam, 30 to 50 % slopes	LkF, Lyonsville-Jiggs soils, 50 to 70 percent slopes
CoE, Cohasset very stony loam, mod. deep, 8 to 50 % slopes	RxF, Rockland
CrE, Cohasset-McCarthy complex, 30 to 50 percent slopes	RyF, Rubbleland
CsF, Colluvial land	ShB, Shingletown clay loam, 0 to 8 % slopes
CuD, Cone stony loam, 3 to 30 percent slopes	SoD, Sites stony loam, 8 to 30 percent slopes
CvE, Cone very stony loam, 30 to 50 percent slopes	SpE, Sites very rocky loam, 30 to 50 percent slopes
CwF, Cone very stony loam, moderately deep, 15 to 60 percent slopes	SuD, Supan very stony loam, 0 to 30 % slopes

Summarized in Table E.2.1-1 are the soils found along facilities in the Kilarc Development. Table E.2.1-2 lists the soils found in the Kilarc Development and summarizes key properties related to erosion potential, including soil type, percent slope, and hydraulic conductivity. In this section, each soil is described with context to where the soil is found in the area. In general, the description begins from the bottom of the Kilarc Powerhouse, and continues from the Kilarc Forebay, along the Kilarc Main Canal, to the upper reaches of the canal and various diversion dams (i.e., North Canyon and South Canyon diversion dams).

The Windy and McCarthy very stony sandy loams are found in the vicinity of the Kilarc Powerhouse, and underlie the Kilarc Main Canal at its headwaters, Spillway 1, and South Canyon Creek Spillway and Siphon, as well as border the canal through most of its length along its northern margin. The Windy and McCarthy very stony sandy loam is found on steep slopes (50 to 75 percent) ranging in elevation from 2,000 to 9,000 feet. The soil is composed of residuum of weathered volcanic rock and basalt, respectively. The loams are well drained, range in depth from 48 to 52 inches, have low to high hydraulic conductivity, and low available water capacity.

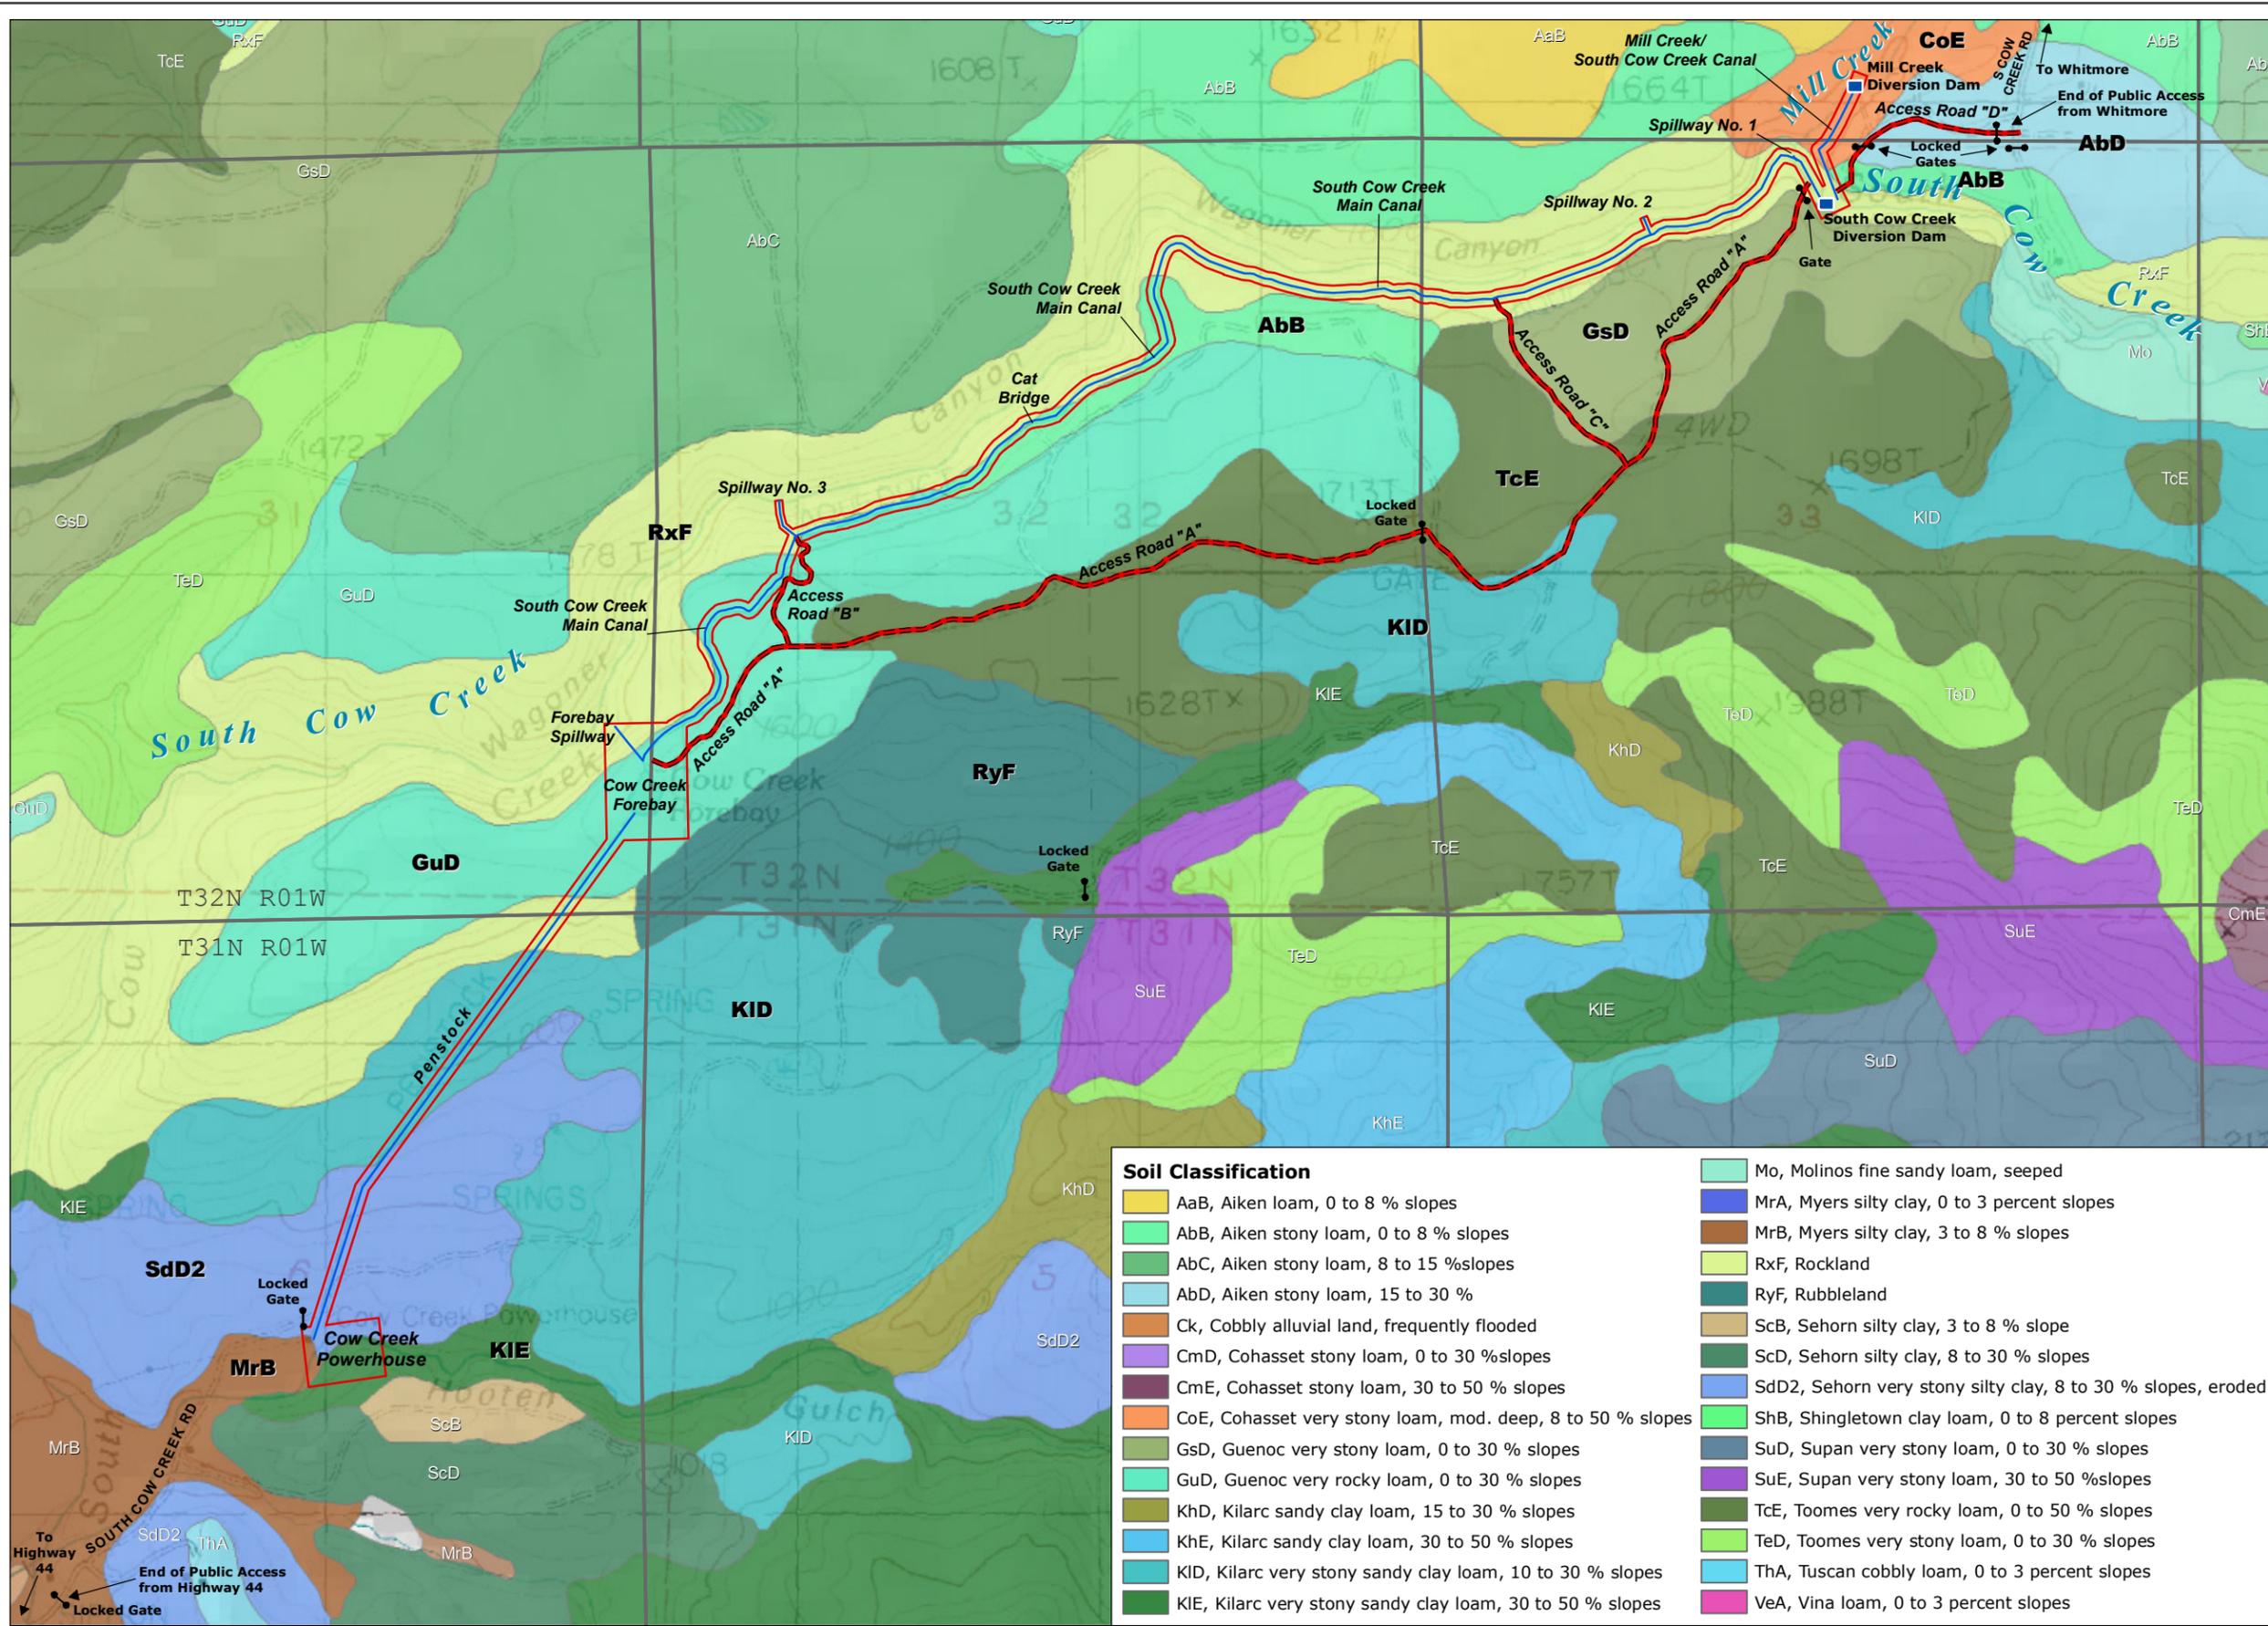
Data Source: Natural Resource Conservation Service, 2008a. United States Department of Agriculture. Custom Soil Resource Report for Shasta County Area, California - Cow Creek.

Soil Classification	
 AaB, Aiken loam, 0 to 8 % slopes	 MrA, Myers silty clay, 0 to 3 percent slopes
 AbB, Aiken stony loam, 0 to 8 % slopes	 MrB, Myers silty clay, 3 to 8 % slopes
 AbC, Aiken stony loam, 8 to 15 %slopes	 RxF, Rockland
 AbD, Aiken stony loam, 15 to 30 %	 RyF, Rubbleland
 Ck, Cobbly alluvial land, frequently flooded	 ScB, Sehorn silty clay, 3 to 8 % slope
 CmD, Cohasset stony loam, 0 to 30 %slopes	 ScD, Sehorn silty clay, 8 to 30 % slopes
 CmE, Cohasset stony loam, 30 to 50 % slopes	 SdD2, Sehorn very stony silty clay, 8 to 30 % slopes, eroded
 CoE, Cohasset very stony loam, mod. deep, 8 to 50 % slopes	 ShB, Shingletown clay loam, 0 to 8 percent slopes
 GsD, Guenoc very stony loam, 0 to 30 % slopes	 SuD, Supan very stony loam, 0 to 30 % slopes
 GuD, Guenoc very rocky loam, 0 to 30 % slopes	 SuE, Supan very stony loam, 30 to 50 %slopes
 KhD, Kilarc sandy clay loam, 15 to 30 % slopes	 TcE, Toomes very rocky loam, 0 to 50 % slopes

KhE, Kilarc sandy clay loam, 30 to 50 % slopes	 TeD, Toomes very stony loam, 0 to 30 % slopes
 KID, Kilarc very stony sandy clay loam, 10 to 30 % slopes	 ThA, Tuscan cobbly loam, 0 to 3 percent slopes
 KIE, Kilarc very stony sandy clay loam, 30 to 50 % slopes	 VeA, Vina loam, 0 to 3 percent slopes

Table E.2.1-3 lists soils found along the Cow Creek Development. Table E.2.1-4 lists soils found in the Cow Creek Development and summarizes key properties related to erosion potential, including soil type, percent slope, and hydraulic conductivity. Each soil is described with context to where the soil is found in the area. In general, the description begins from the Cow Creek Powerhouse, running northeast to the Mill Creek and South Cow Creek diversion dams.

The Sehorn very stony silty clay occurs in the Cow Creek Development from the Cow Creek Powerhouse and up the Cow Creek Penstock for approximately 0.25 mile. Found on 8 to 30 percent slopes, the Sehorn very stony silty clay occurs on hills ranging in elevation from 300 to 2,000 feet. The soil is composed of residuum from weathered sedimentary rock that is well drained. It ranges in depth to more than 80 inches, has a very low to moderately high hydraulic conductivity, and a low available water capacity.

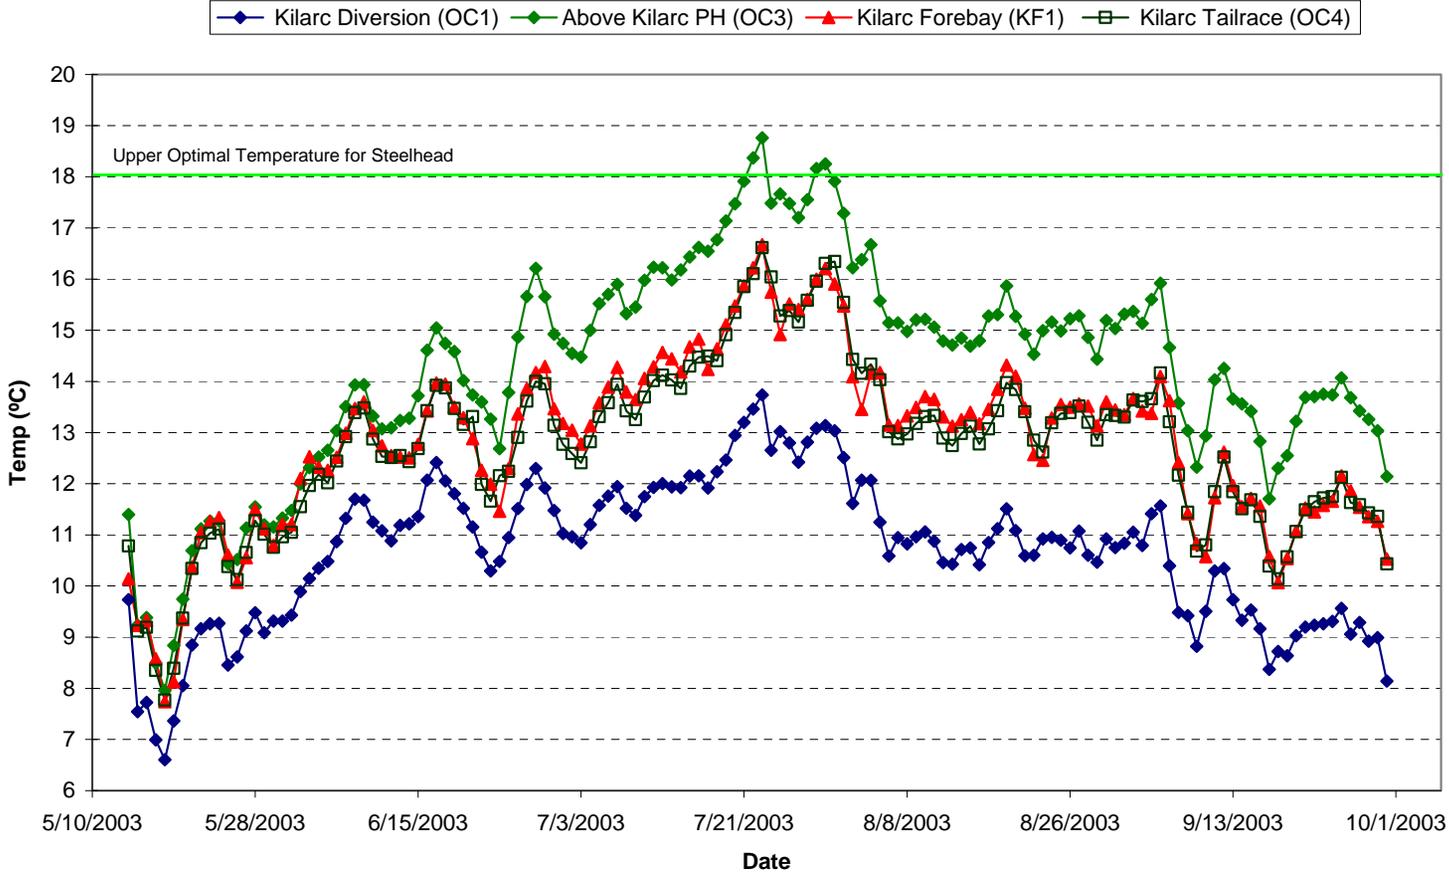
Figure E.2.4-2. Comparison of 2003 Daily Mean Temperatures, Kilarc Development

2003 Temperatures in Old Cow Creek
(Daily Mean)

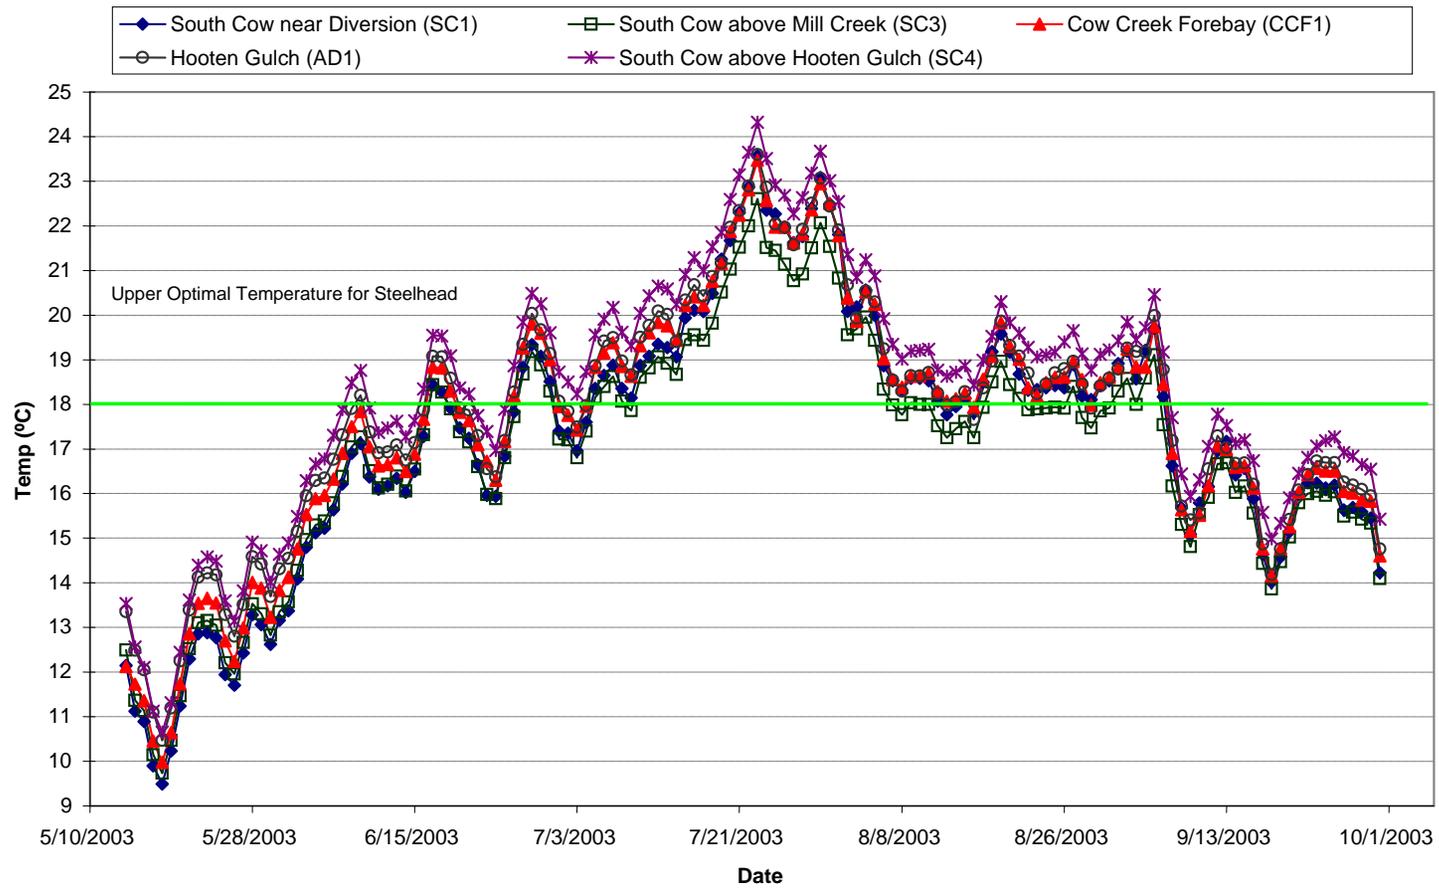
Figure E.2.4-3. Comparison of Daily Mean Temperatures, Cow Creek Development

2003 Temperatures on South Cow Creek (Daily Mean)

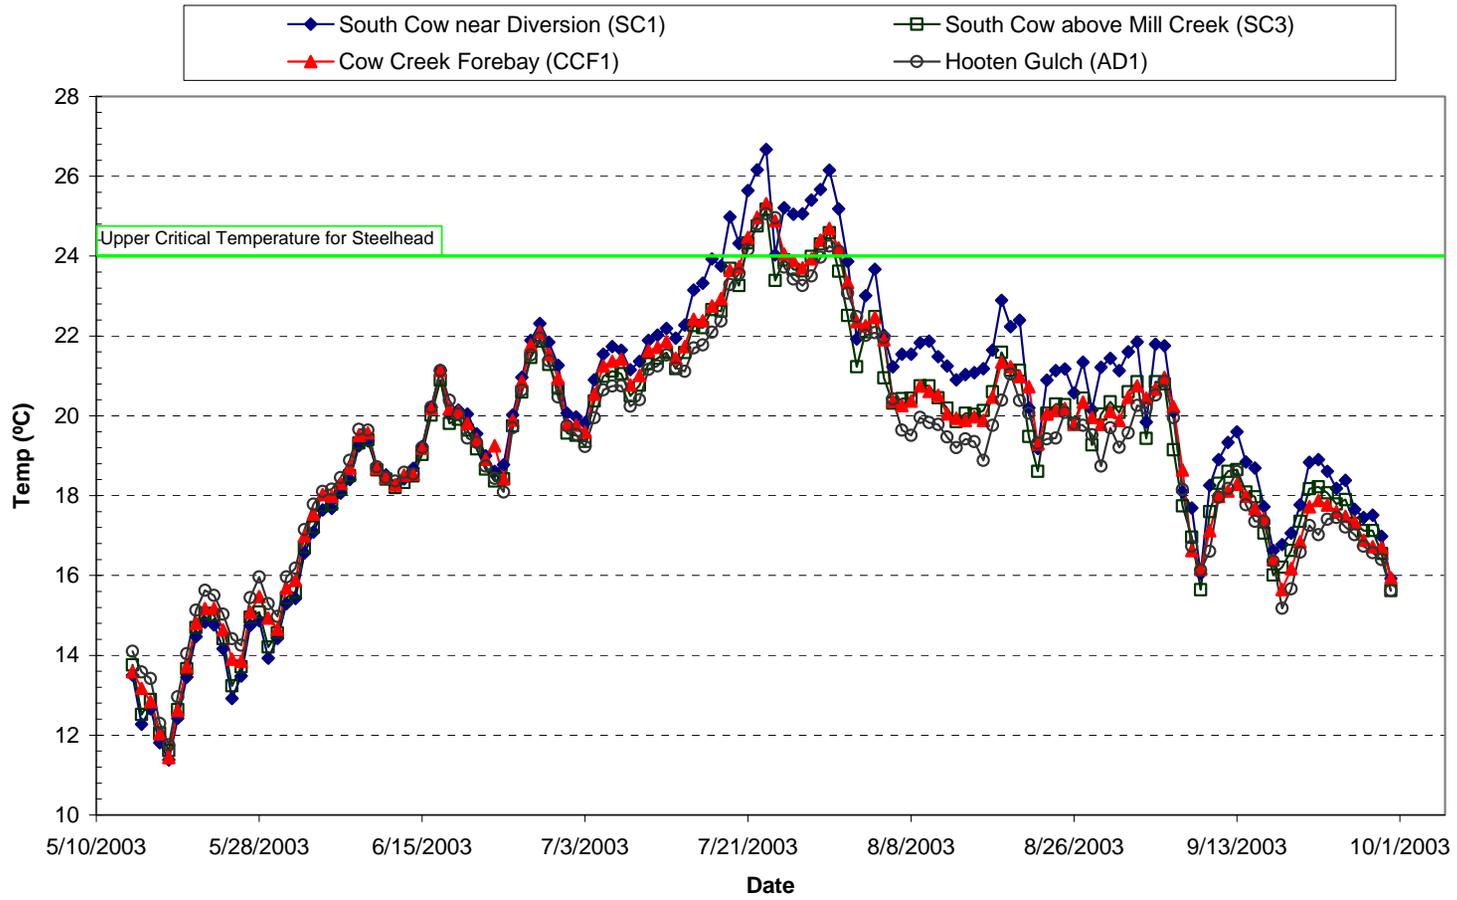
Figure E.2.4-4. Comparison of Daily Maximum Temperatures, Cow Creek Development

Comparison of Temperature Stations (Daily Maximum)
